## Bridle Path Stream Restoration

McLean, Virginia

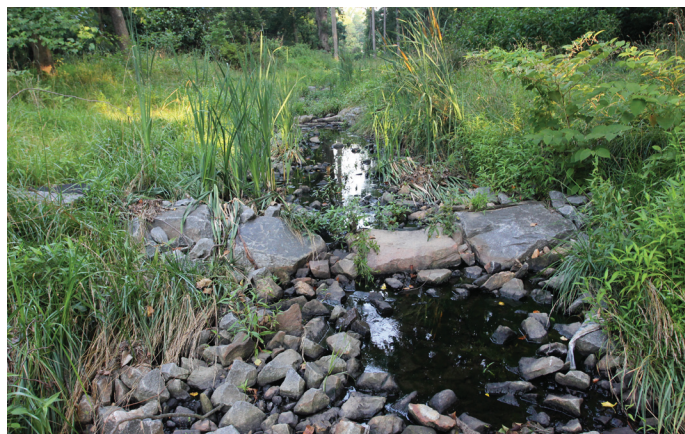
*from top: Restored stream; Severely eroded banks before restoration*

*This project eliminated severe bank erosion, while restoring aquatic and riparian habitat along 1,700 linear feet of suburban stream.*

channel design practices, and enhanced aquatic and terrestrial habitat along the stream and its drainage outfall channels. The selected approach raised the bed of the channel to alleviate bank shear stresses and reconnect the floodplain. A low bench was designed to accommodate more frequent floodflows. In-stream structures made of stone boulders were installed to maintain grades, dissipate energy and reduce erosion, and create habitat diversity. Special care was taken in developing the proposed alignment and channel bed elevations to minimize bank regrading and tree loss along homeowners' properties.
