Davis Branch Stream Restoration

Woodstock, Maryland

A unique swath of preserved rural land in a rapidly developing watershed is enhanced when stability, habitat, and ecological function are restored to a degraded stream and floodplain system.

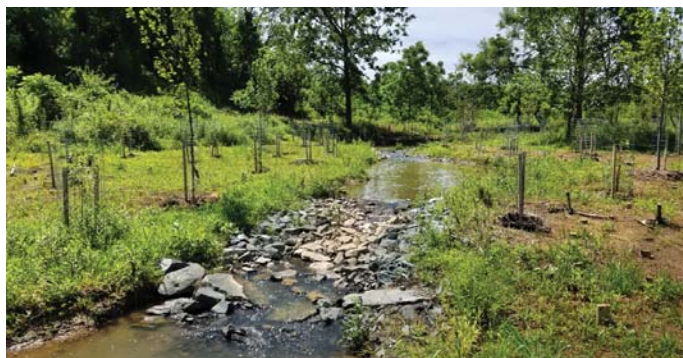
from top: Constructed riffles restore the connection between the in-stream and riparian habitats; Large woody debris add complexity to aquatic habitats; Oxbow wetlands provide breeding habitat for amphibians
