CLEAN WATER SERVICES

Fanno Creek Bank Restoration—Crawford Property

Beaverton, Oregon

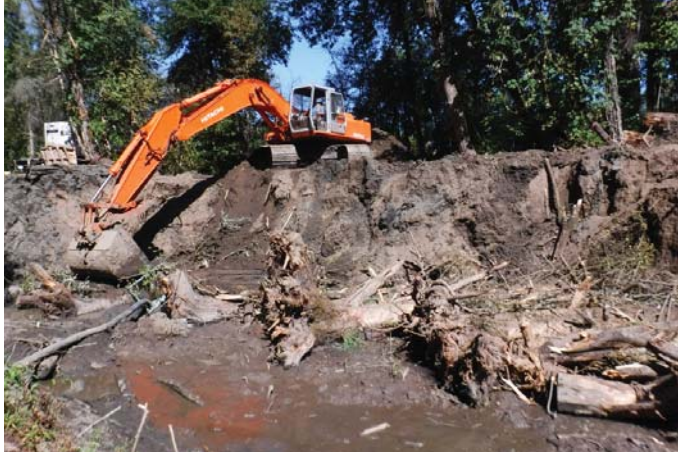
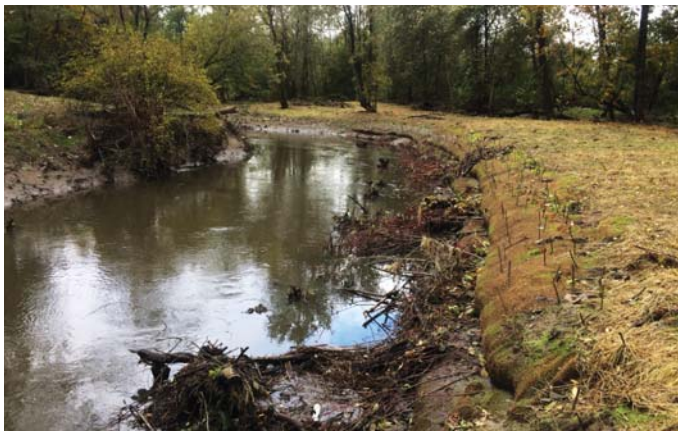
from top: During construction; Immediately after restoration

Woody debris structures provide bank stability and habitat enhancement to an urbanized creek.

Biohabitats worked with CWS staff to install a bioengineered stream bank stabilization structure. Materials included over 20 root wads, 40 logs, slash, willow cuttings, and coir fabric lifts. Project elements included the diversion of Fanno Creek

and dewatering of the isolated work zone. Biohabitats used 10" electric submersible pumps to divert up to 10 cubic feet per second throughout the duration of the project. Biohabitats coordinated fish rescue and salvage efforts.

The reach now has bank stability that includes a large woody debris habitat element providing cover for fish and other aquatic species during high flow events. When Fanno Creek accesses its floodplain, the floodplain structures provide a measure of habitat cover as well.
