## Galisteo Creek Stream Restoration

Santa Fe County, New Mexico

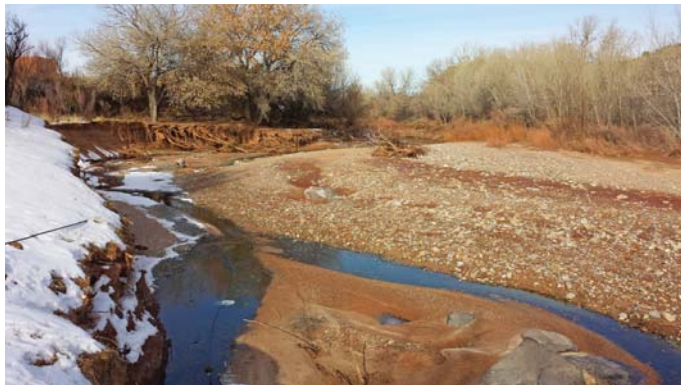
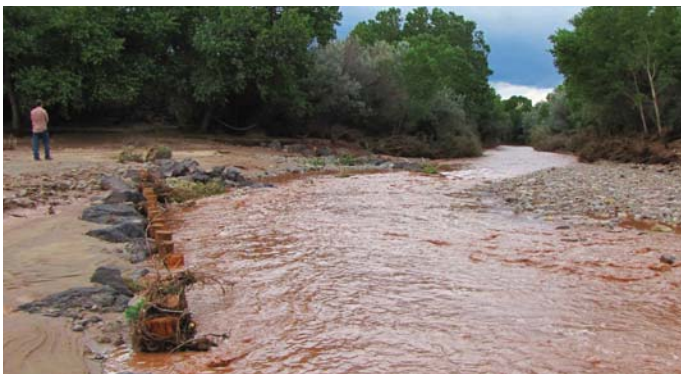
from top: Initial conditions; Restored creek after large flood event

The outside bend of the meander was reinforced with timber post vanes to keep the channel thalweg away from erodible banks. Large boulders were placed on the upstream side of the post vanes and live willow cuttings were installed to deter end-around erosion of the post vanes. The outside bend flood plain overbank was kept low to allow early flooding and willow and cottonwood cuttings were installed on the bench to reduce velocities near the bank.

During the 2014 summer monsoon season, Galisteo Creek experienced several high-intensity flood events. The restored channel withstood the flood stress and riparian plantings took hold.
