Ivy Creek Stream Restoration

Albemarle County, Virginia

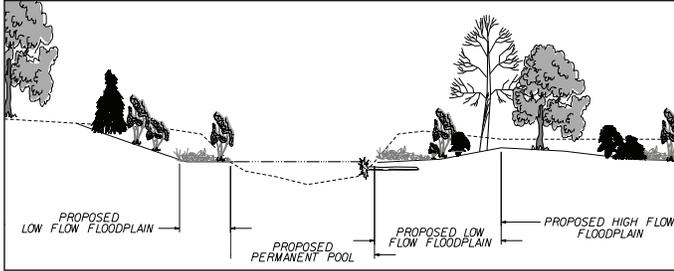
top: Concept drawing
middle and bottom: Initial conditions

Complicating the restoration was the presence of multiple beaver impoundments in and immediately downstream of the project area. Biohabitats' design, which reconnected the floodplain, stabilized eroding stream banks and improved in-channel habitat, allowed the project to meet its goals without being compromised by the continued presence of the beaver.
