Alger Park Stream Restoration

Washington, DC

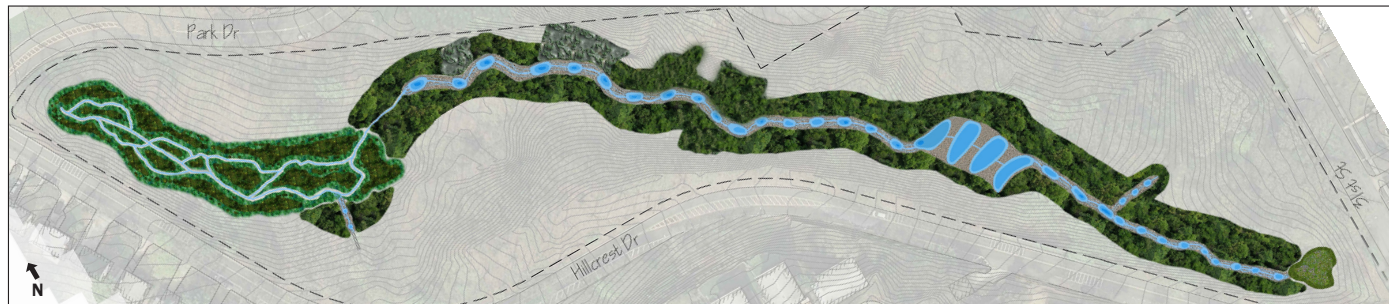
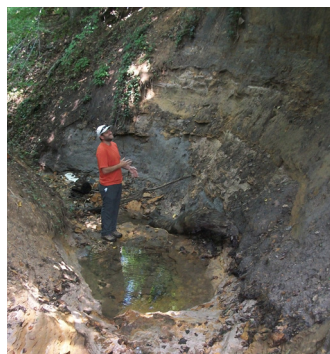
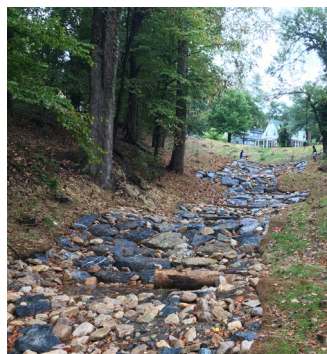
clockwise from top: Stream restoration design; Severely eroded initial conditions; After restoration

habitat, and water quality, Biohabitats developed a design to restore 1500 linear feet of the stream. The upstream portion of the stream had steeply eroding valley slopes and stream banks, severe channel incision, and numerous headcuts. The downstream portion was a depositional area for a significant volume of sediment scoured from upstream reaches. A combination of excessive unmanaged stormwater flows from outfalls and overland flow pathways, along with steep topography, highly erodible soils, and invasive vegetation, contributed to impairments in the stream and surrounding park land.

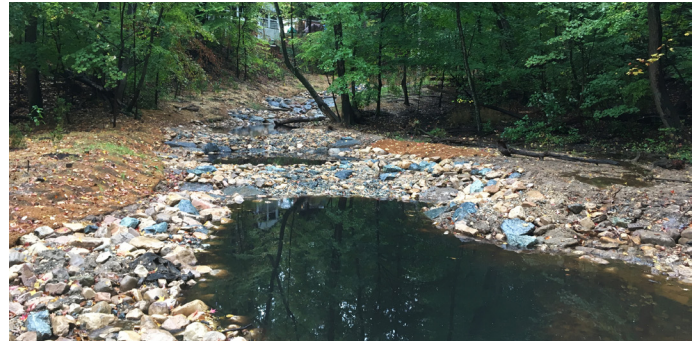
Step pools slow and retain stormwater
