Bacon Ridge Stream and Floodplain Restoration

Crownsville, Maryland

The first stream restoration project in Maryland to use only wood harvested on site to restore floodplain functions.

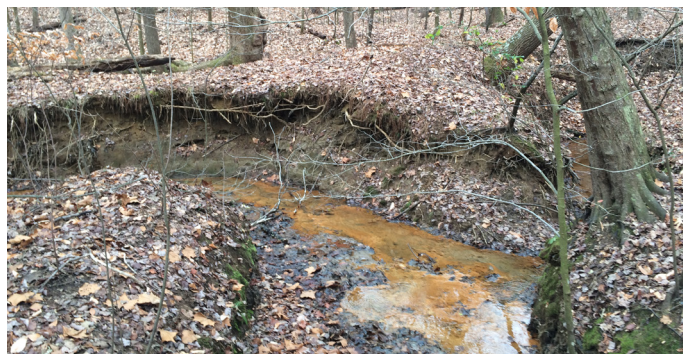
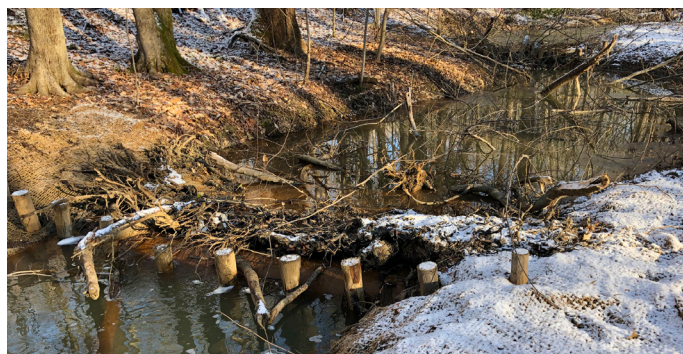
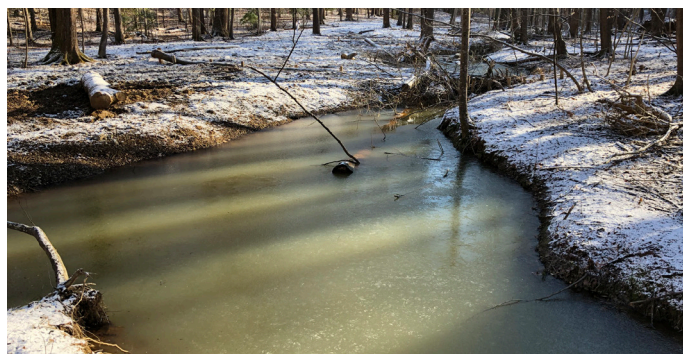
From top: Eroded stream channel before restoration; in-stream engineered wood structure; the stream during construction

Much of the stream channel contained visible signs of erosion including lateral migration, toe slope failures, and active head cutting and incision. These issues decreased groundwater levels and storm-flow access to the floodplain, and increased sediment supply to the downstream reaches, thus degrading water quality. To restore approximately 2,850 linear feet of mainstem channel, along with 1,500 linear feet of side channel, the

Using 90 in-stream engineered wood structures, harvested on-site, the team installed log jam grade controls and valley-wide sill structures across the floodplain to achieve floodplain reconnection while limiting the development of channel avulsions and nick points. This restoration created long-term bed and bank stability, slowed storm water flows to reduce sediment and improve water quality, and enhanced the ecological functions of non-tidal wetland and stream habitats.
