## Bridle Path Stream Restoration

McLean, Virginia

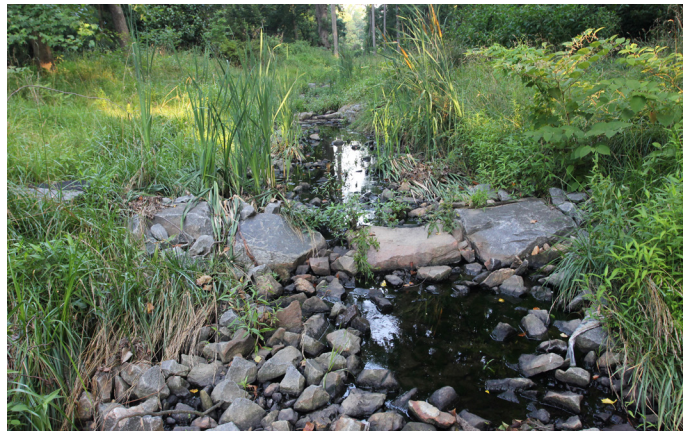
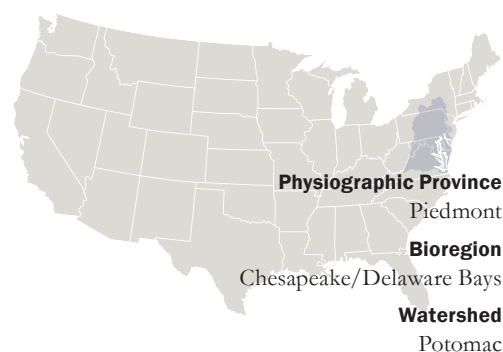
*from top: Restored stream; Severely eroded banks before restoration*

*This project eliminated severe bank erosion, while restoring aquatic and riparian habitat along 1,700 linear feet of suburban stream.*

channel design practices, and enhanced aquatic and terrestrial habitat along the stream and its drainage outfall channels. The selected approach raised the bed of the channel to alleviate bank shear stresses and reconnect the floodplain. A low bench was designed to accommodate more frequent floodflows. In-stream structures made of stone boulders were installed to maintain grades, dissipate energy and reduce erosion, and create habitat diversity. Special care was taken in developing the proposed alignment and channel bed elevations to minimize bank regrading and tree loss along homeowners' properties.
