Dabney State Park Large Wood Placement

Multnomah County, Oregon

Portland Water Bureau

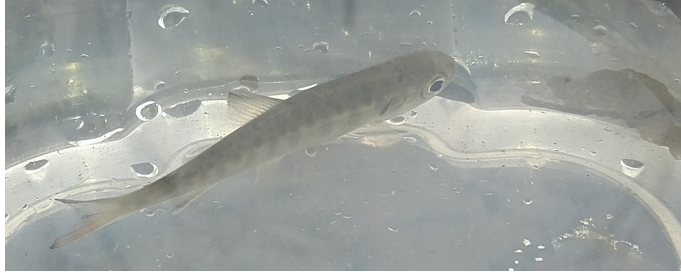
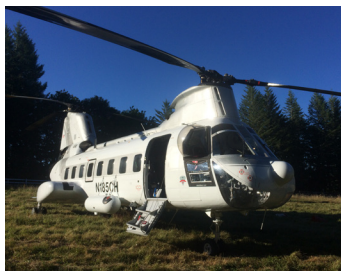
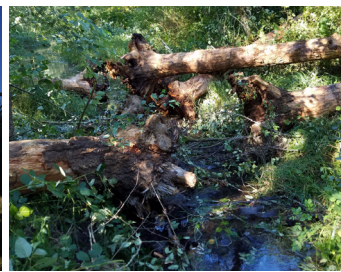
clockwise from top: Juvenile coho (Oncorhynchus kisutch) observed in newly installed pool; Large woody debris installed for stability and habitat; Helicopter delivery of cobble and logs minimized forest impacts

Leveraging our team's unique strategic experience with low-impact deployment of heavy machinery and large natural materials in highly sensitive natural environments, the Biohabitats construction crew excavated about 2,000 feet of new channel. To limit impacts to the mature floodplain forest, a Columbia Model 107-II heavy lift helicopter was used

to deliver and install 60 tons of native cobble and 30 logs in the channel to provide habitat complexity and stability. Because the project took place in a popular public park during peak recreation season, Biohabitats coordinated reinforcing layers of safety tactics during these operations, including constant radio communications, temporary park closures, signage, and foot traffic control measures.

After project completion, native trees and vegetation were planted in the surrounding riparian areas, and with the first seasonal high flows after project completion, juvenile coho salmon (*Oncorhynchus kisutch*) were observed finding refuge among the newly installed pools, gravel and logs.
