Erie County Red Jacket Park

Erie County, New York

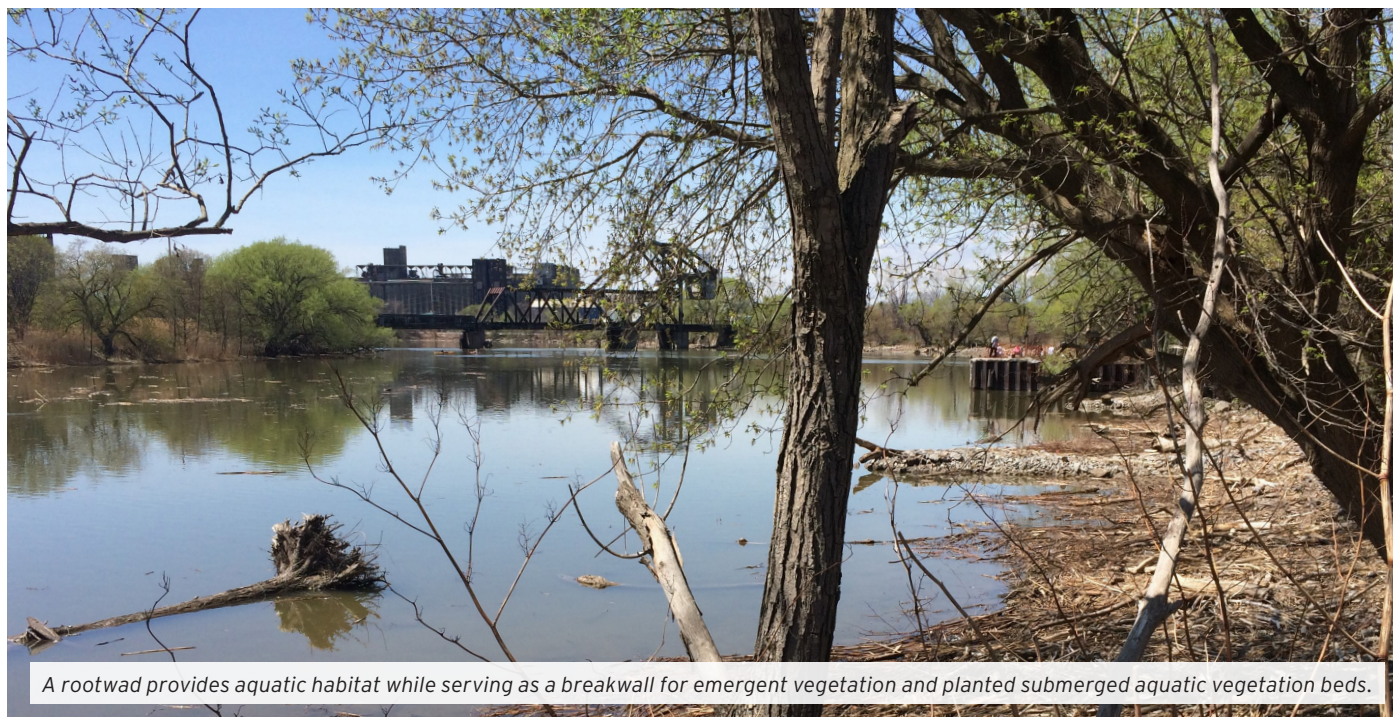
A rootwad provides aquatic habitat while serving as a breakwall for emergent vegetation and planted submerged aquatic vegetation beds.

A new series of rock weirs along the shoreline encourages the deposition of sediment and replaces critical shallow-water habitat lost during the dredging. Submerged aquatic vegetation and emergent vegetation provide additional habitat. Invasive species were treated in the riparian areas, and a "living" fence was planted along the property lines to limit invasive plant encroachment and provide habitat and a native seed source.
