Flints Grove Stormwater Management Pond Retrofit & Stream Restoration

North Potomac, Maryland

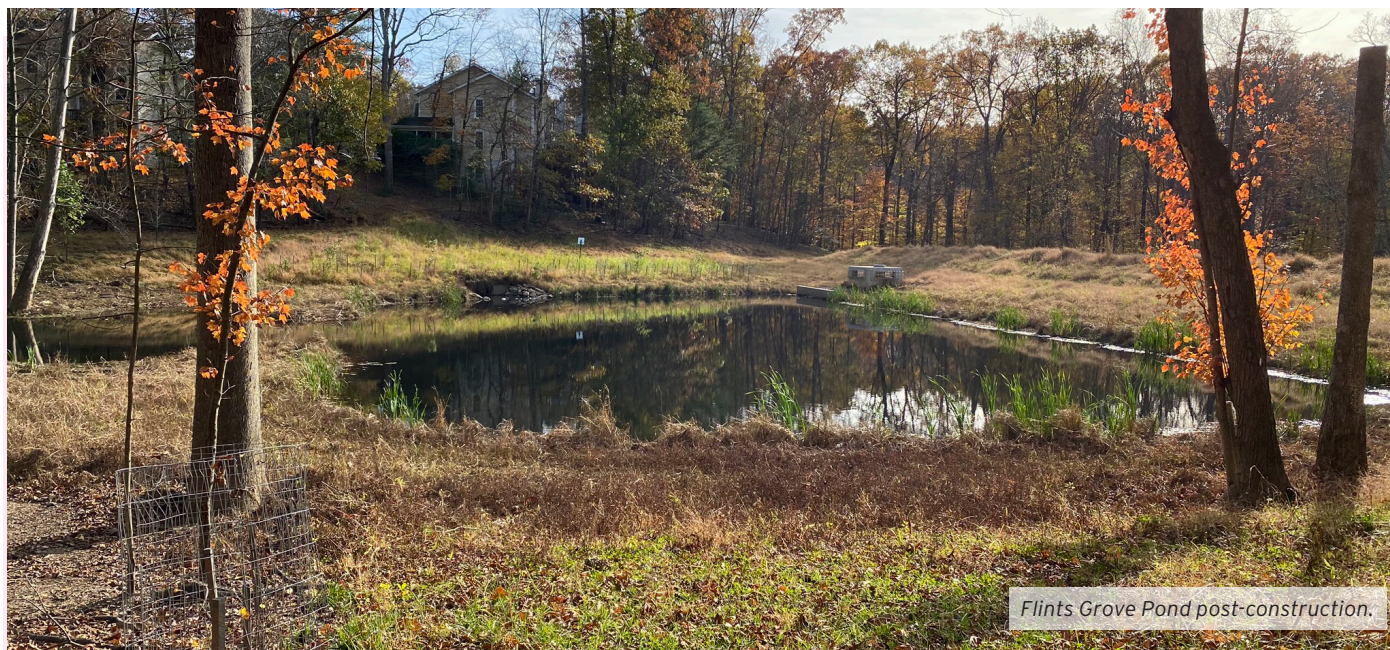
Flints Grove Pond post-construction.

Biohabitats' design not only retrofitted the outdated facility in accordance with the latest criteria and with State and County safety standards, but it also restored 1200 LF of the degraded stream and its adjacent floodplain. The retrofit involved the creation of a wet pond designed to enhance quantity and quality control and achieve the Water Quality Volume and the Channel Protection Volume for the drainage area. The metal riser structure was replaced with a concrete structure to achieve restoration goals and extend the life of the facility. The existing principal spillway was sliplined with a HDPE liner maintaining the capacity and providing long term stability. A clay core, clay face, filter diaphragm, and embankment grading brought the pond into compliance with current MD378 regulations. An aquatic bench planted with wetland species serves as a safety feature while providing habitat for native flora and fauna. The stream restoration, which consisted of the creation of riffle-pool and cascade-pool sequences, created a stable stream corridor and minimized sediment contributions to the pond. The riparian corridor was planted with native grasses, shrubs, and trees to provide further habitat and ecological benefits.
