Gales Creek Bank Stabilization and Enhancement

Forest Grove, Oregon

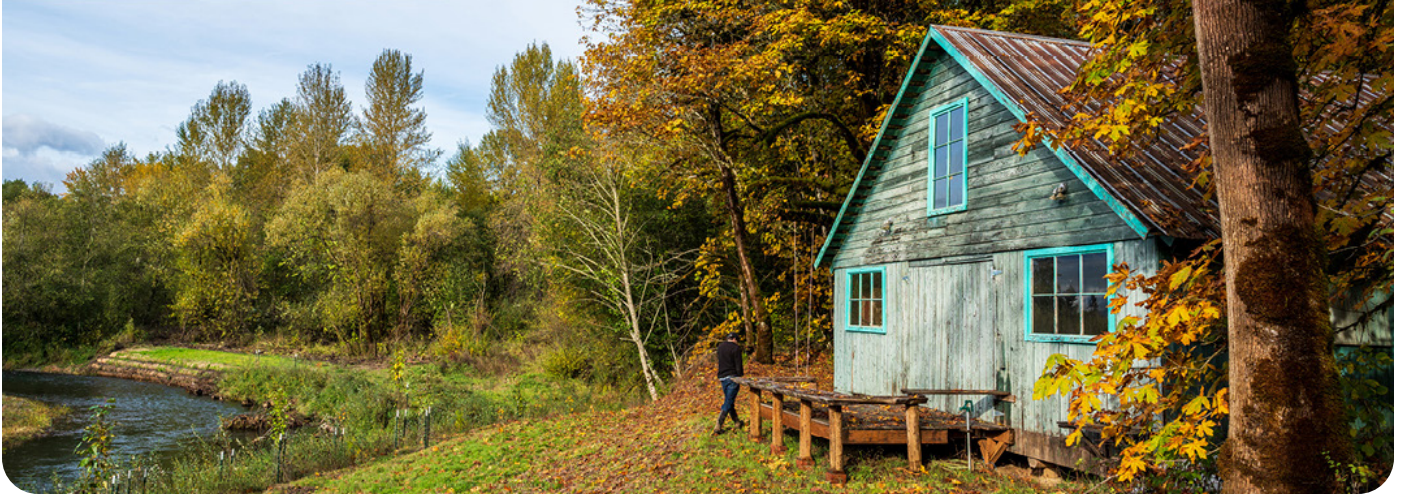
Bioengineering construction methods restored and stabilized nearly 300 linear feet of eroding riverbank.

To restore nearly 300 feet of stream bank, some of which had eroded, leaving a 15 foot vertical bank and threatening a historic dance hall on the property, Biohabitats Construction turned to bioengineering techniques. The crew began by safely diverting water from the channel, salvaging fish and aquatic wildlife and creating an equipment access route to enable the restoration to occur. The team then used large wood and coir fabric-wrapped soil lifts to stabilize and improve habitat along the eroding bank and installed engineered log structures to increase habitat diversity. Following construction, the Biohabitats crew seeded native riparian grasses to stabilize the bank. The property owner, who was fully engaged throughout each phase of the project, has continued to install native plantings, and the Biohabitats Construction crew frequently visits the site to monitor its progression.
