Hawkins Cove Design-Build

Annapolis, Maryland

Stream and wetland restoration in a densely developed area of Annapolis, Maryland reduces pollutants entering the Chesapeake Bay and contributes to watershed-scale stormwater remediation.

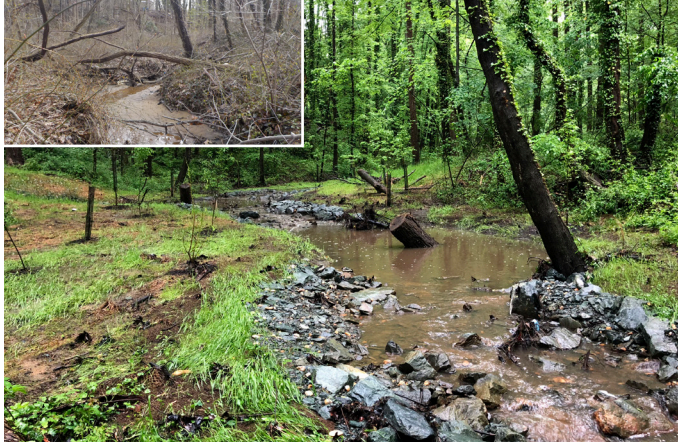
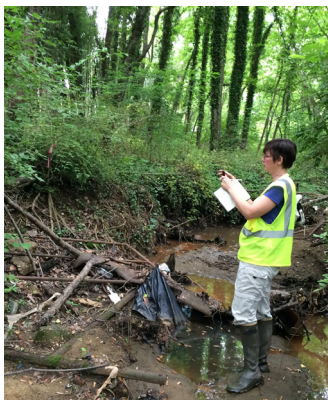
from top: Restored stream with inset of initial conditions; Documenting trash and rubble within the incised main stem channel before construction

Working closely with the Spa Creek Conservancy, its constituents, and community members, Biohabitats led the implementation of stream and wetland restoration at Hawkins Cove. The restoration, which was designed within the existing, incised channel alignment, involved raising the stream bed elevation to connect to adjacent floodplain areas. This approach allows the system's ecological function to be improved, rather than degraded, by increasingly frequent flooding events, as flows now enhance adjacent wetlands. The restoration approach will also help to passively remove invasive vegetation within the project area by changing the soil moisture regime.
