Left Hand Creek Restoration at 63rd Street Extension

Boulder County, Colorado

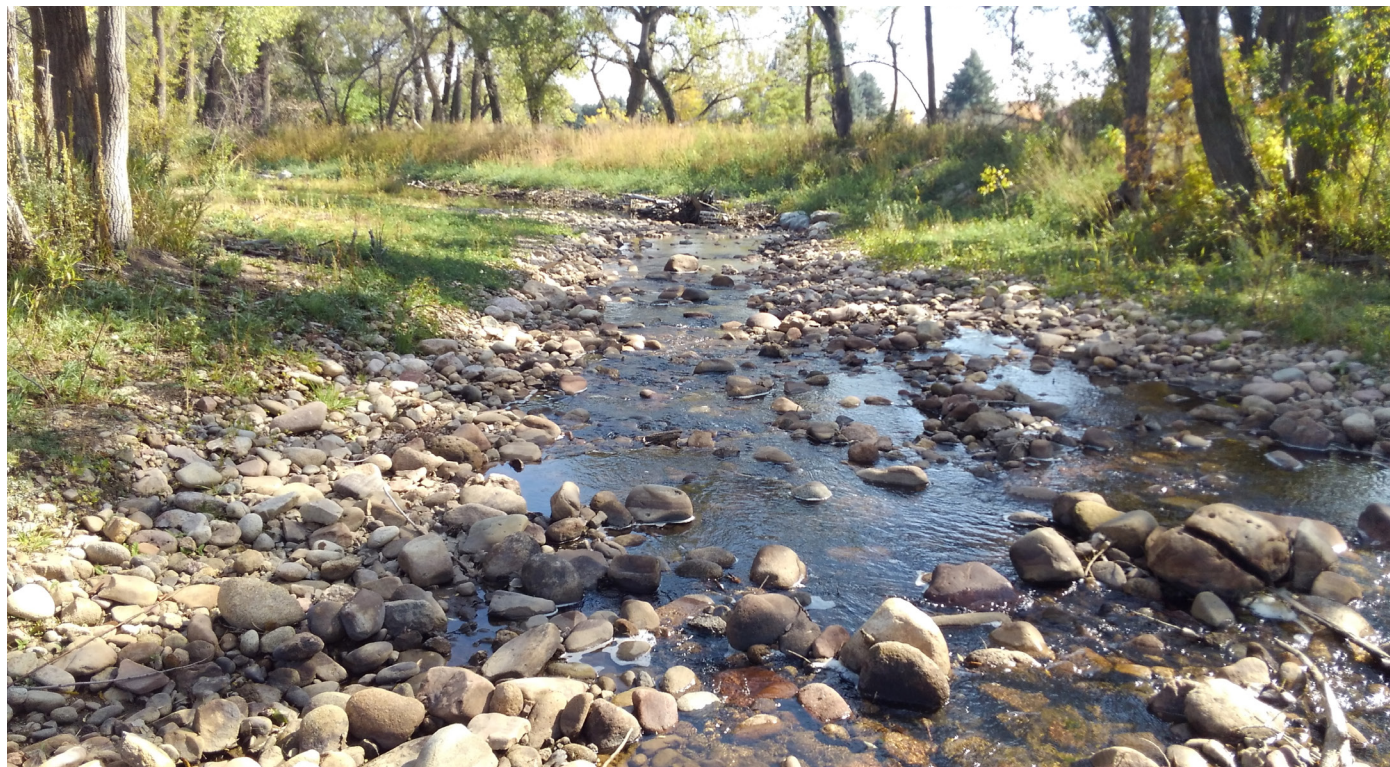
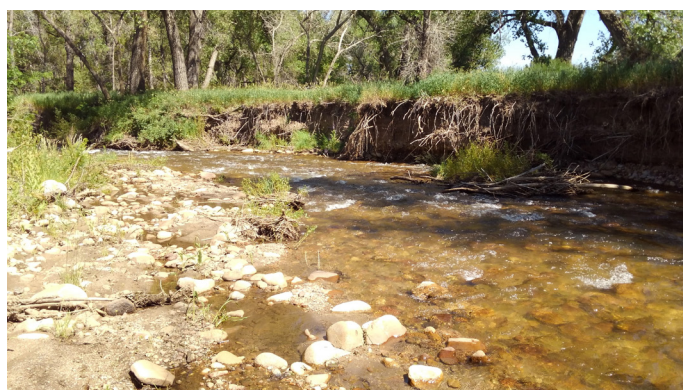
From top: LHC 63rd Street Project post-construction with pool installation, streambed stabilization and floodplain benches; Prior to restoration with high eroded banks in background.

Left Hand Excavating and Biohabitats worked together on this 5,800 LF stream restoration project. Due to the impacts of the 2013 flood, this reach of Left Hand Creek had severe erosion with very tall cut banks, few ponds, and limited floodplain benches that were still covered with flood sediment and debris. The project extended from the Haystack Mountain Golf Course to 63rd Street and involved multiple private landowners. Scope of work included permitting, concept and 30% design, extensive landowner outreach, and construction to restore and repair associated flood damage. The implemented design included pool installation, channel re-shaping, streambed stabilization, grading and shaping to create floodplain benches, in-stream and bank habitat structures, bank repair, utilization of natural materials, and planting and seeding. The restoration design and planting plan were tailored to individual property owners' inputs while still maintaining a holistic approach so the entire reach would function as a resilient stream system.
