Lower Jemez River Fish Structure Restoration Design

Santa Fe National Forest, New Mexico

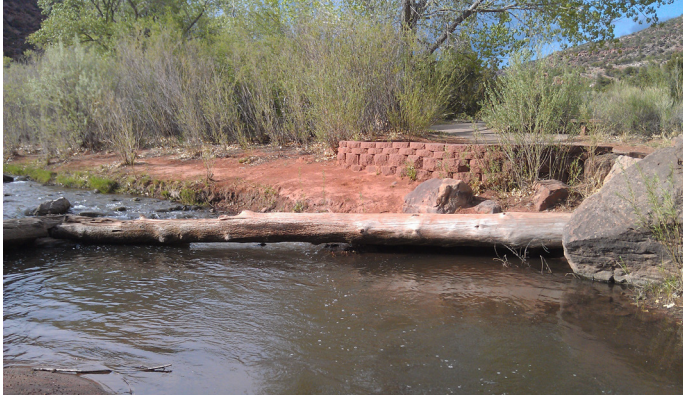
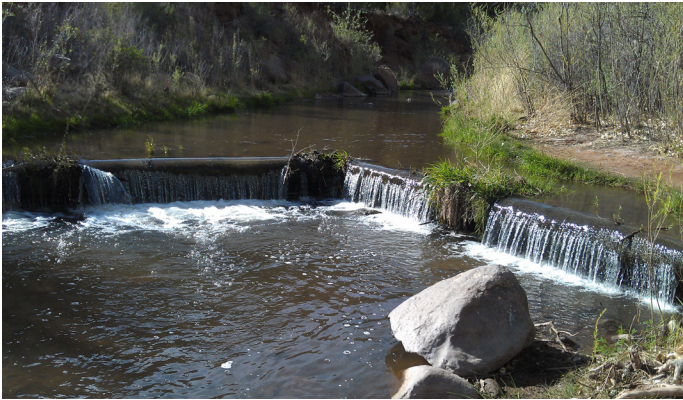
Top and above: Current conditions

In 1989, as part of the Lower Jemez River Corridor Project, nine v-notch log structures were installed along a seven-mile reach of the river in an effort to enhance fish habitat. These structures are now in various states of failure, resulting in severe riverbed and bank erosion.
