Moores Branch at Lightfoot Tributary Stream Restoration

Pikesville, Maryland

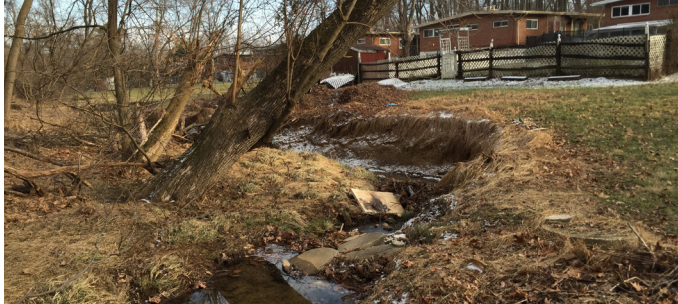
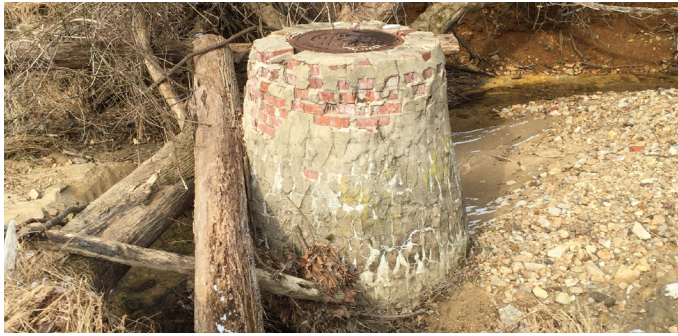
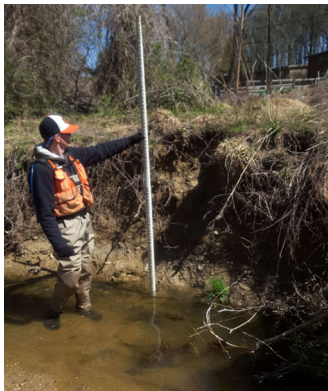
from top: Initial conditions with severely eroded banks; Exposed manhole cover due to erosion; Assessing stream conditions

These land use changes resulted in an increased amount of fast-moving stormwater runoff to the stream network via impervious areas. In concert with hydrologic impacts, changes in land management affecting sediment supply introduced cycles of channel and valley filling, along with channelization. As a result of these changes, portions of Moores Branch suffered headcutting and widening.
