NEREID BOAT CLUB

Nereid Shoreline Stabilization

Rutherford, New Jersey

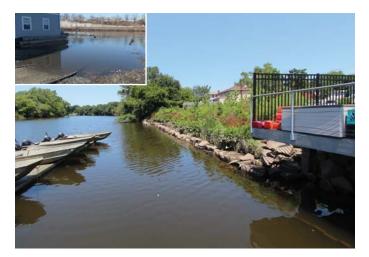
from top: Living shoreline with inset of typical Nereid flooding; Raingarden helps manage stormwater on the site

site's stormwater management problems, Biohabitats designed a natural system featuring a rain garden and a living shoreline. Using native plantings, strategic grading, and ecological restoration techniques, Biohabitats designed, constructed, and installed a "living shoreline" to replace the dilapidated bulkhead. This new shoreline simultaneously prevents further erosion, enhances stormwater management and local ecology, and restores the river bank to a more natural state.
