# Quail Valley #2 Storm Water Pond Retrofit

Gaithersburg, Maryland

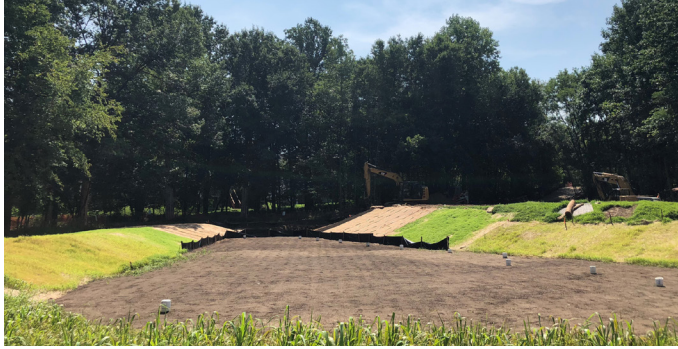
*Water quality, stream health, and ecological function is improved by upgrading and restoring a stormwater pond and degraded stream.*
