SOUTHERN UTE INDIAN TRIBE

Rock Creek III, IV & V, and Ignacio Creek Stream Restoration Design-Build

La Plata County, Colorado

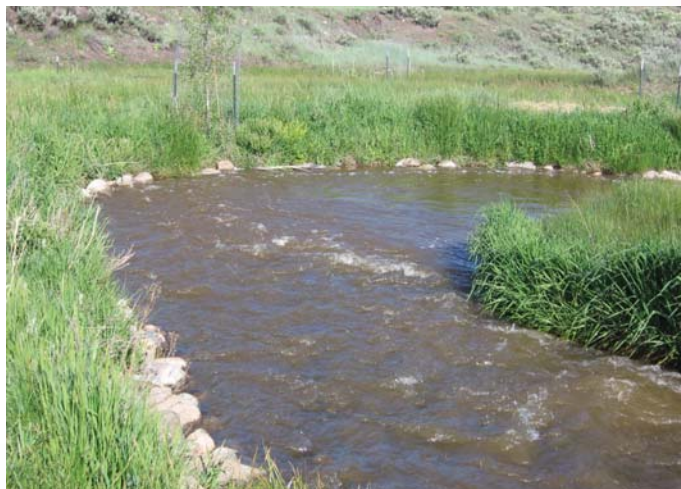
Sequential phasing upstream to downstream accommodated funding sources and provided opportunities to modify and improve restoration techniques including channel realignment, bank stabilization, habitat improvements, and revegetation.
