SANTA FE COUNTY

Santa Fe River Greenways

Santa Fe County, New Mexico

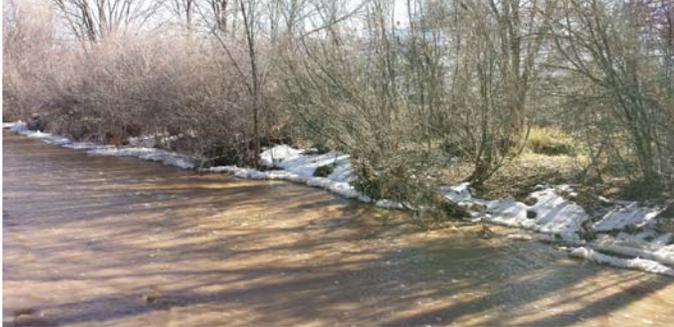
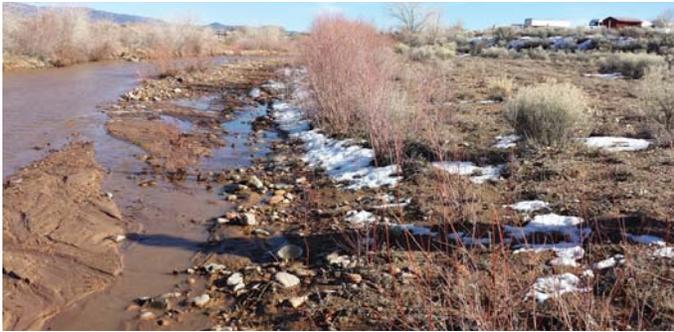
Channel incision in the reach is severe in places due to past disturbance by mining activities which is made worse by flashy urban runoff. Banks have eroded and the flood plain has become disconnected from the channel in many sections exacerbating stability problems. Non-native exotic plant species have invaded the abandoned flood plains.

In incised reaches the Biohabitats design employs boulder grade control structures to raise the degraded channel bottom. Boulder side slope protection reinforced with native willow plantings provides protection from high water velocities at the outsides of bends in the channel. Channel grades were adjusted to allow normal river flows to reach the flood plain. The design specifies removal of exotic trees and re-establishment of native species.
