CITY OF BROOKLYN

# Stickney Creek Stream Stabilization and Floodplain Restoration

Brooklyn, Ohio

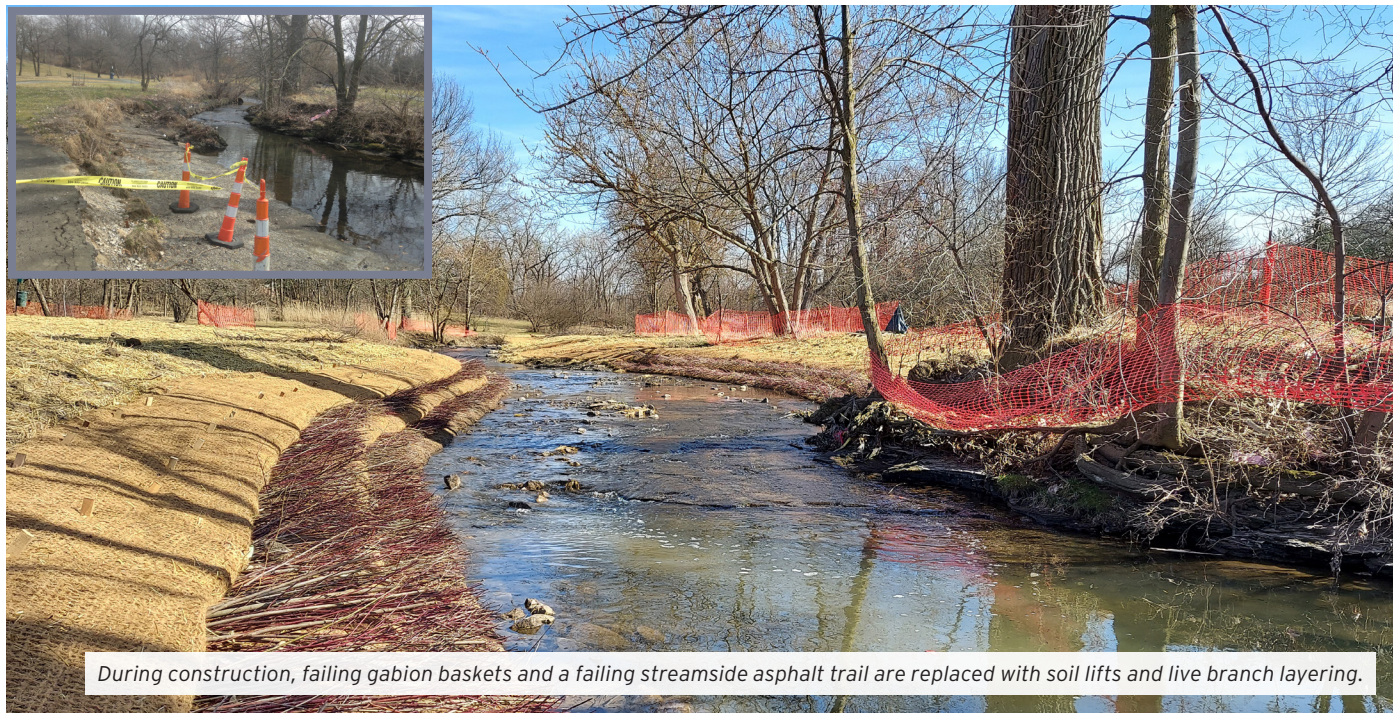
During construction, failing gabion baskets and a failing streamside asphalt trail are replaced with soil lifts and live branch layering.

The restoration involves regenerating more than 1,500 linear feet of the natural stream system, including six acres of associated floodplain. The restoration design, which features boulder toe, toe wood, and buried soil riprap protection and soil lifts with live branch layering, also involves improving and relocating streamside trails and enhancing viewsheds.
