Tallman Property Fish Passage Restoration

Clatskanie, Oregon

A 12-foot diameter simulated streambed culvert provides year-round passage for all aquatic species at all life stages under all stream discharge conditions within a watershed important to Oregon's salmon recovery efforts.

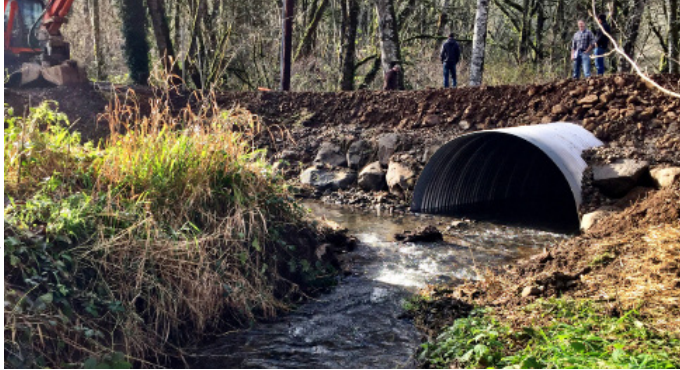
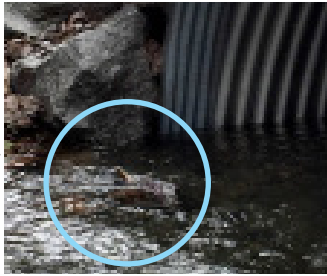
from top: After restoration; Adult coho salmon (*Oncorhynchus kisutch*) traveling upstream immediately following re-watering; Initial conditions

Immediately following the re-watering of the simulated stream bed culvert, Biohabitats crews observed several adult coho salmon (*Oncorhynchus kisutch*) traveling upstream through the culvert toward their spawning areas on Keystone Creek.

Due to the importance of providing passage for fall coho, an in-water work extension was granted by the Oregon Department of Fish and Wildlife to replace the existing culvert with a fish-passable culvert capable of handling flood flows. The variance allowed Biohabitats to perform work within Keystone Creek through November 15, 2016. Biohabitats coordinated temporary utility relocations, and provided site dewatering, diversion, and fish rescue preconstruction services. A 40-foot long, 12-foot diameter corrugated metal pipe

was installed with a simulated stream bottom substrate to provide fish and aquatic species passage for all life stages at all stream discharges. Biohabitats also restored the portion of Keystone Creek above the culvert to its pre-flood alignment and condition, improved the Tallman's driveway, and provided native seed and willow revegetation services.
