Tarryall Creek Stream Restoration Design-Build

Park County, Colorado

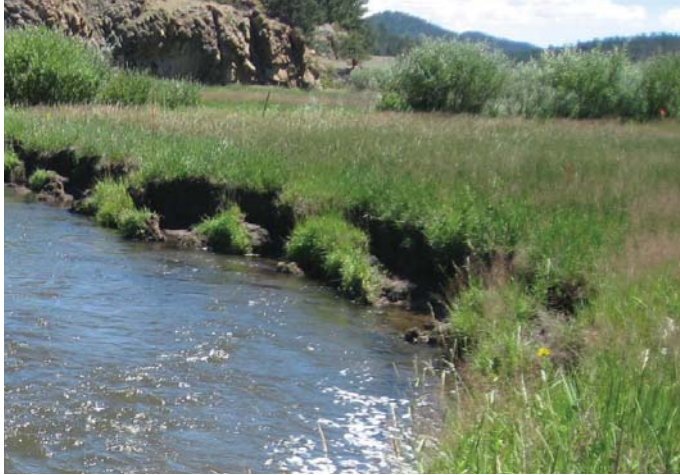
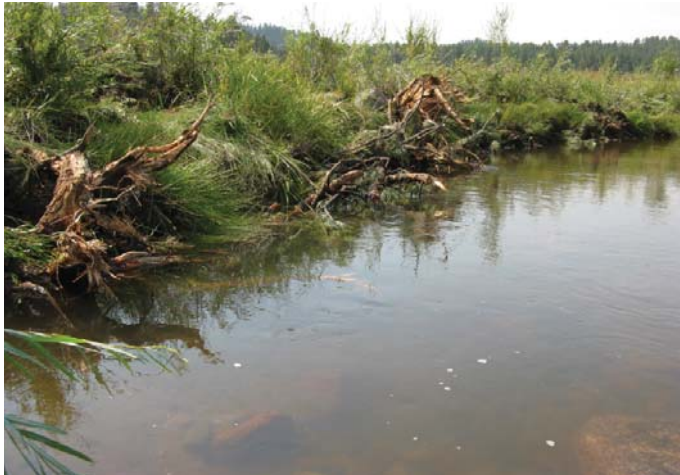
top: Eroding bank typical of pre-restoration conditions
bottom: Stream bank following restoration

The stabilization of Tarryall Creek restored prime trout habitat, returned willows to the riparian corridor, and greatly reduced sediment production in the creek.

The design restored a stable pattern and dimension to the degraded reaches while maintaining the existing, stable riffle/pool sequences. Trees and boulders from another location on the ranch were harvested and used to construct log vanes, rootwads, and large, woody debris. These structures, along with gravel/cobble point bar material and transplanted willow clumps, were combined to stabilize eroding banks while also creating cover for trout.
