Stream Restoration at UVA's College at Wise

Wise, Virginia

Regenerative design transforms a degraded, ditched stream into an ecologically functioning system and a campus amenity.

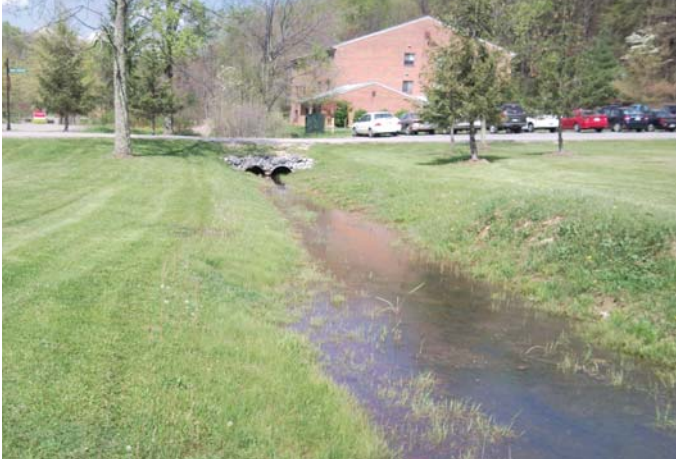
top: Initial conditions; above: Immediately after construction
