ANNE ARUNDEL COUNTY DEPARTMENT OF PUBLIC WORKS

## Crofton Tributary Stream Restoration

Anne Arundel County, Maryland

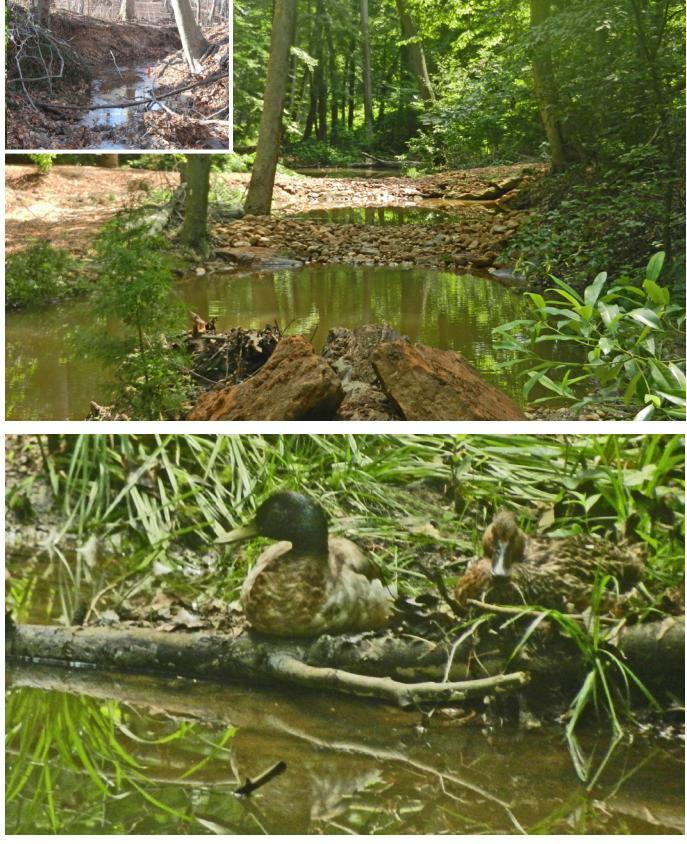
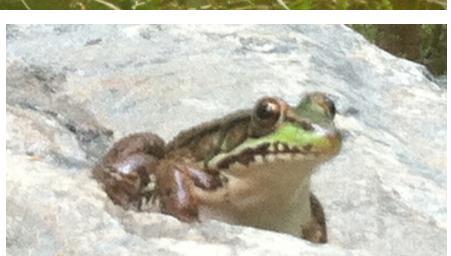
top: Post construction with inset of initial conditions; above & right: Restored ecology along the stream

In 2007, Biohabitats was awarded a contract to develop a stream restoration design for the tributary. The goal was to restore watershed processes, including recharging the groundwater table to regenerate spring seeps. Biohabitats' design reconnected the channel to its floodplain. This approach eliminates high and eroding banks, improves water quality and creates conditions favorable for native Anne Arundel County coastal plain biota while naturally controlling invasive species. The restoration design package included cost estimates, construction details, specifications and implementation guidance (e.g. sequence of operations, operation & maintenance). The reconstructed portion of the channel now functions naturally.
