FAIRMOUNT PARK COMMISSION, NATURAL LANDS RESTORATION & ENVIRONMENTAL EDUCATION PROGRAM

## Fairmount Park Wissahickon Watershed, Gully Restoration Design-Build

Philadelphia, Pennsylvania

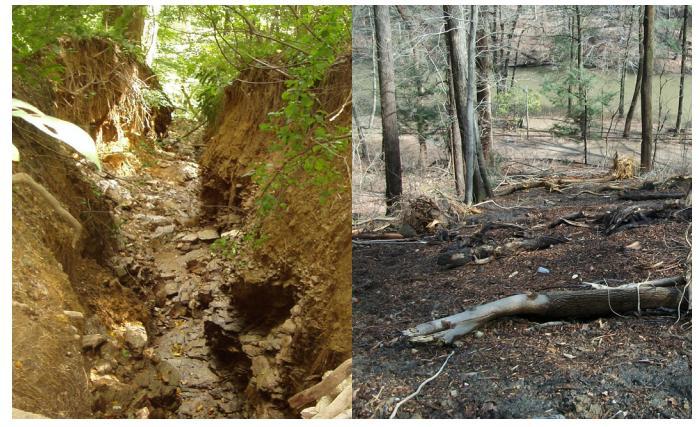
from left: Initial conditions with gully; Gully after restoration

Two of the restoration sites were located within the Park's Walnut Lane Golf Course. At one site, gully erosion from golf course runoff had become a safety hazard and was threatening a fairway. Biohabitats restored the gully and headwater stream using a regenerative stream channel technique which uses a carbon-rich sand bed in combination with pools and riffle grade controls to filter and provide safe, nonerosive stormwater runoff from the golf course. In another part of the golf couse, Biohabitats daylighted a piped
