clean water services Fanno Creek Bank Restoration–Crawford Property

Beaverton, Oregon

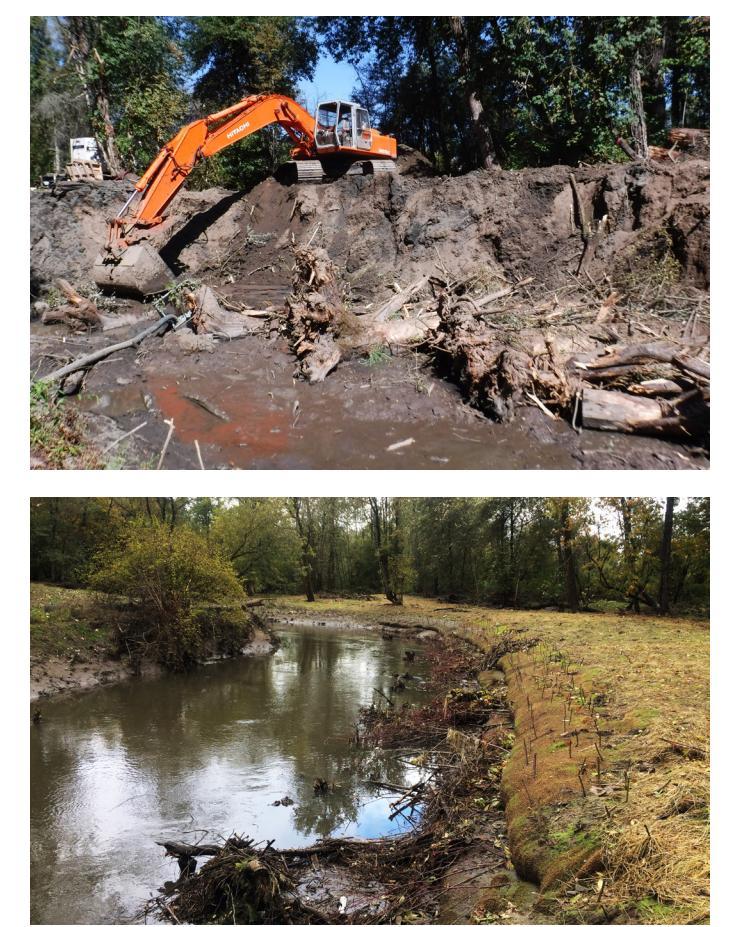
from top: During construction; Immediately after restoration

Woody debris structures provide bank stability and habitat enhancement to an urbanized creek.

Biohabitats worked with CWS staff to install a bioengineered stream bank stabilization structure. Materials included over 20 root wads, 40 logs, slash, willow cuttings, and coir fabric lifts. Project elements included the diversion of Fanno Creek and dewatering of the isolated work zone. Biohabitats used 10" electric submersible pumps to divert up to 10 cubic feet per second throughout the duration of the project. Biohabitats coordinated fish rescue and salvage efforts.

The reach now has bank stability that includes a large woody debris habitat element providing cover for fish and other aquatic species during high flow events. When Fanno Creek accesses its floodplain, the floodplain structures provide a measure of habitat cover as well.
