## NORTH CAROLINA ECOSYSTEM ENHANCEMENT PROGRAM

## Glade Creek On-Call Stream Restoration Services for North Carolina Ecosystem Enhancement Program

Alleghany County, North Carolina

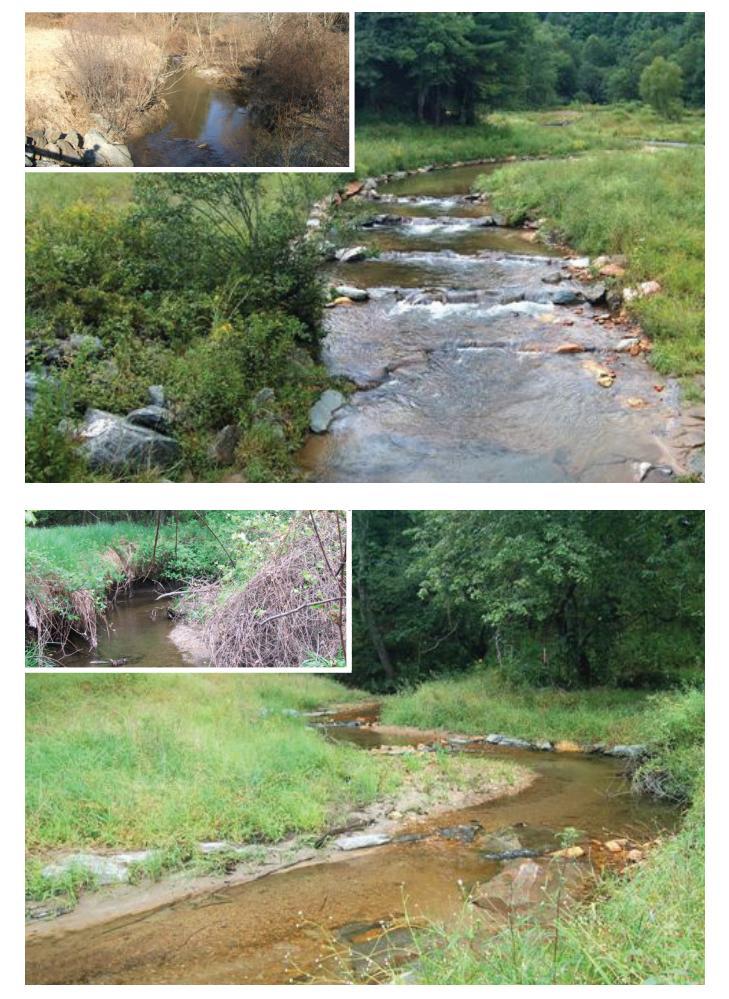
top: Looking upstream on Glade Creek from bridge, postconstruction with initial conditions inset; above: Lower tributary after restoration, with repaired banks with initial conditions inset

The Glade Creek stream restoration project repaired badly eroded banks, reduced sedimentation in stream water and improved trout and aquatic life habitat.
