COLUMBIA COUNTY SOIL AND WATER CONSERVATION DISTRICT Tallman Property Fish Passage Restoration

Clatskanie, Oregon

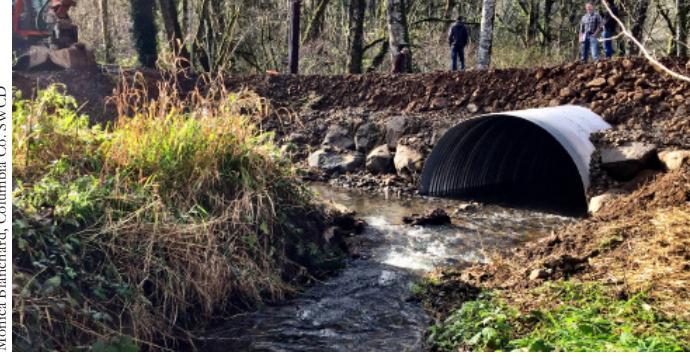
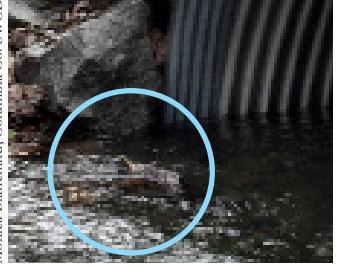
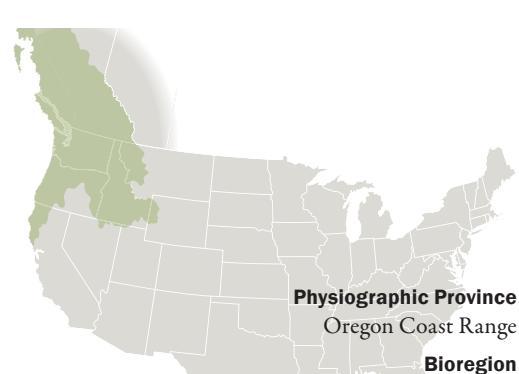
from top: After restoration; Adult coho salmon (Oncorhynchus kisutch) traveling upstream immediately following re-watering; Initial conditions

Due to the importance of providing passage for fall coho, an in-water work extension was granted by the Oregon Department of Fish and Wildlife to replace the existing culvert with a fish-passable culvert capable of handling flood flows. The variance allowed Biohabitats to perform work within Keystone Creek through November 15, 2016. Biohabitats coordinated temporary utility relocations, and provided site dewatering, diversion, and fish rescue preconstruction services. A 40-foot long, 12-foot diameter corrugated metal pipe

was installed with a simulated stream bottom substrate to provide fish and aquatic species passage for all life stages at all stream discharges. Biohabitats also restored the portion of Keystone Creek above the culvert to its preflood alignment and condition, improved the Tallman's driveway, and provided native seed and willow revegetation services.

Immediately following the re-watering of the simulated stream bed culvert, Biohabitats crews observed several adult coho salmon (Oncorhynchus kisutch) traveling upstream through the culvert toward their spawning areas on Keystone Creek.
