Breewood Stream Restoration and LID Retrofit

Wheaton, Maryland

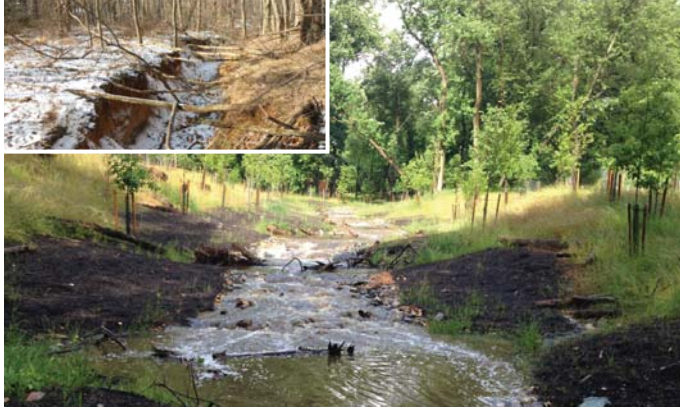
Restored stream immediately after planting with inset of severely eroded initial conditions
