KOREN DEVELOPMENT COMPANY, INC.

Greenspring Quarry South Tributary Stream Restoration

Baltimore County, Maryland

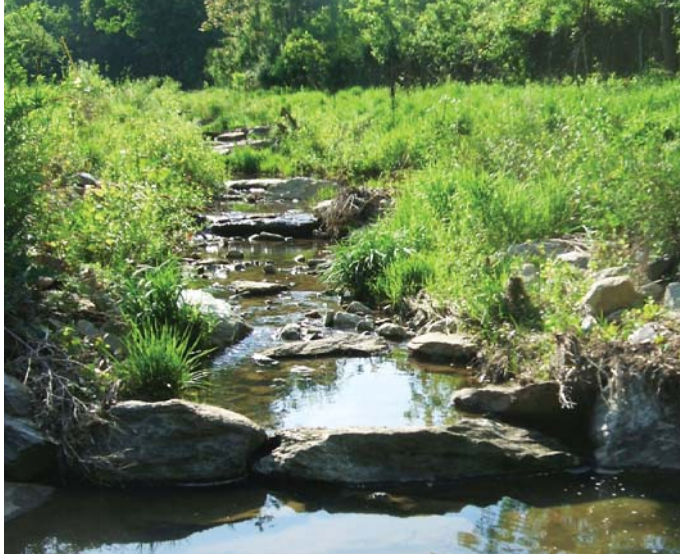
A previously channelized stream now functions naturally and provides an attractive amenity in a community that was once a limestone quarry.

Using comprehensive measurements taken from a reference reach, Biohabitats designed the channel to look and function naturally. Details for natural, in-channel structures such as gradual boulder steps and various downed log features were also developed.
