Mirror Lake Remediation and Restoration

Dover, Delaware

Water quality and habitat are restored to a severely distressed and contaminated urban lake.

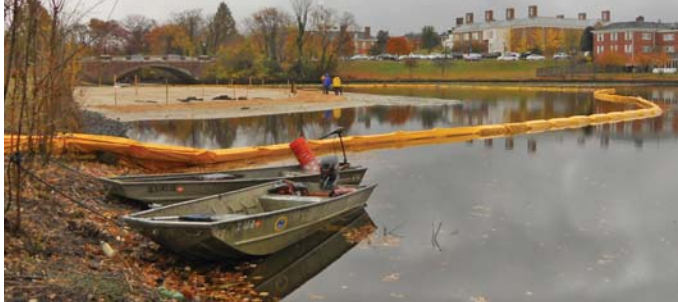
from top: Tidal wetland bench (left background) immediately after planting; Installation of sand utilizing a Telebelt®; Placement of SediMite™ from a boat using compressed air

As part of a multi-phase effort to improve water quality in the watershed, the Delaware Department of Natural Resources and Environmental Control (DNREC) initiated the restoration of Mirror Lake. The project began with remediation. Activated carbon was placed within the lake and surrounding riverine areas in order to bind contaminants in the sediment. Once the carbon was in place, it was the desire of DNREC to also improve the local habitat as well as nutrient cycling within the lake. For help in crafting the design, DNREC turned to Biohabitats.

Biohabitats’ designed a tidal wetland planting area in order to improve both the aesthetics of the area as well as the water quality within the lake. Biohabitats also developed a planting plan for the tidal wetland area to restore native vegetation within the lake that will also provide additional habitat for the species that thrive amongst the wetland vegetation.
