West Creek Stream Restoration

Cleveland, Ohio

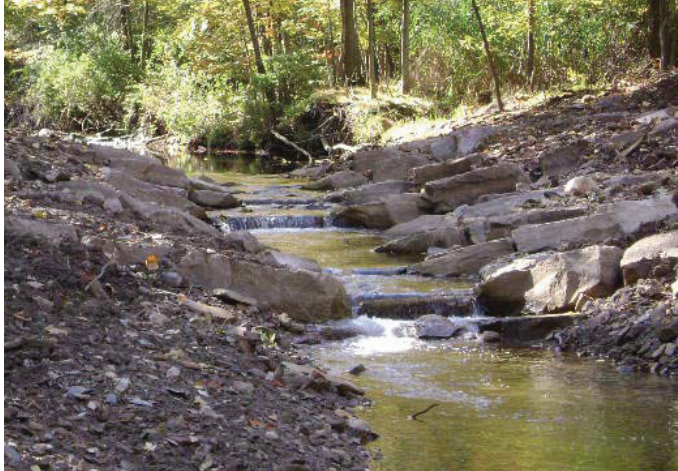
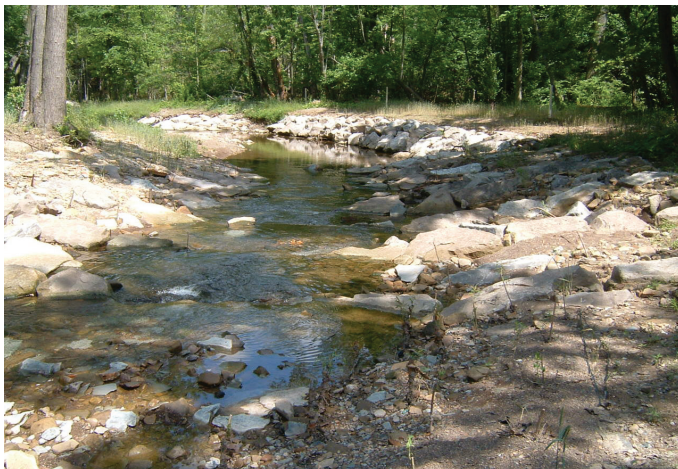
top and bottom: After restoration

A low head dam was removed and rock cascades were installed to provide fish passage and stabilize the stream bed.
