Clean Water Services

Balm Grove Dam Removal

Gales Creek, Oregon

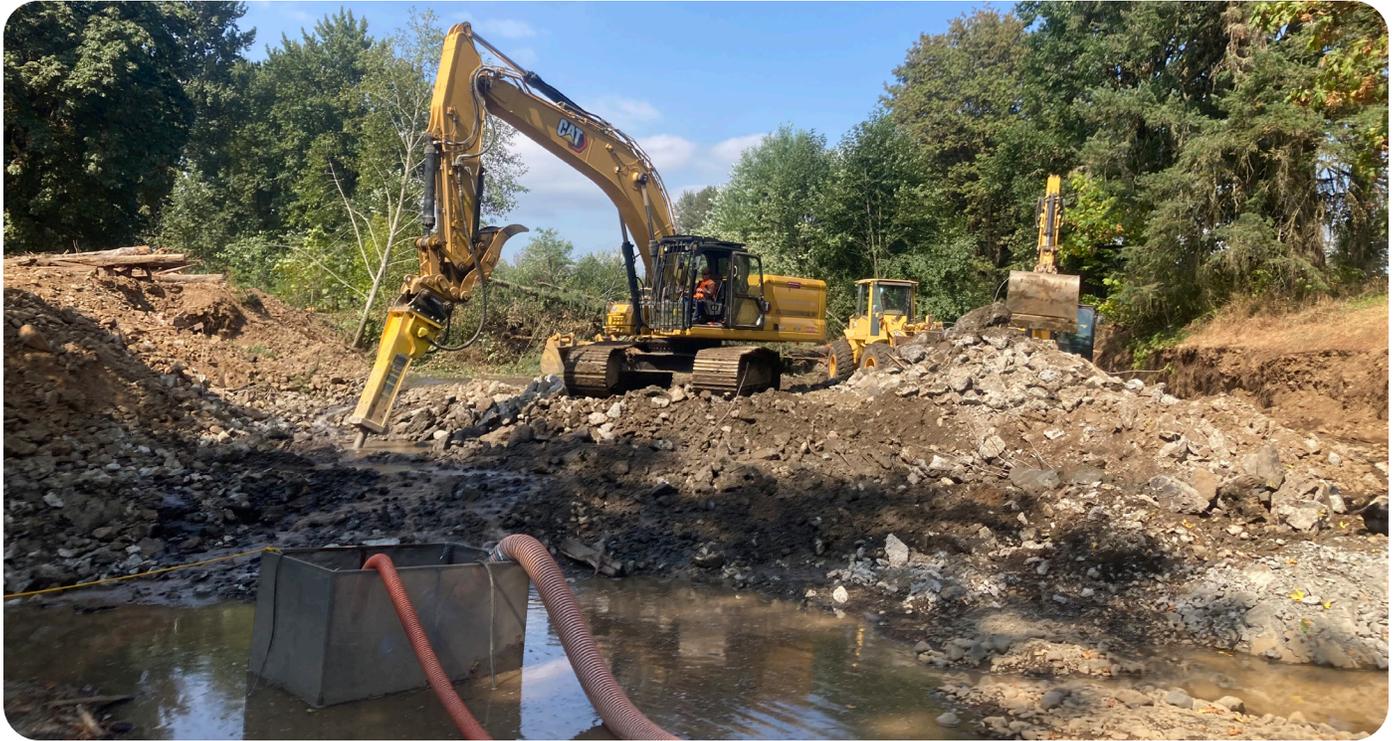
Dam removal opens up and enhances miles of habitat for native migratory fish in the mainstem of Gales Creek, a tributary to the Tualatin River.

Gales Creek offers some of the best fish habitat in Washington County. Thirteen miles upstream from its confluence with the Tualatin River, however, an obsolete dam has altered flows and impeded fish passage since the 1930s. The 30-foot thick, 100-foot wide, 3-foot high dam was originally constructed to create an area for swimming and boating.

Biohabitats helped Clean Water Services remove the dam to restore not only fish passage, but floodplain connectivity and instream habitat. The project involved diverting Gales Creek and dewatering the work area, safely salvaging and transporting fish and amphibians, demolishing, removing, and recycling the entire dam structure including all concrete, headwalls and piles; installing large wood habitat and boulder structures, and restoring all impacted areas to facilitate enhanced habitat.
