UNIVERSITY OF NORTH CAROLINA AT CHAPEL HILL

Battle Grove UNC Regenerative Stormwater Conveyance

Chapel Hill, North Carolina

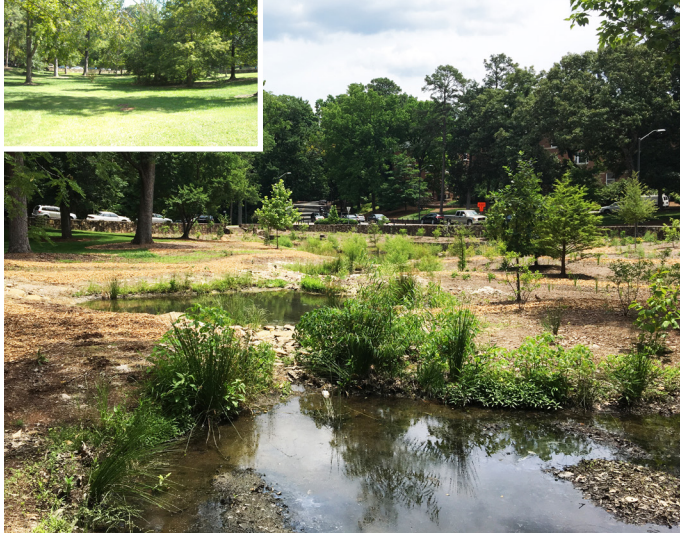
After restoration with inset of initial conditions

The design, which daylighted 280 feet of channel and added 118 feet of additional natural channel, featured a network of sand seepage berms, pools, and cobble weirs. These modifications establish the sand seepage hydrology and create a series of vegetated stilling pools, sand seepage beds

replete with above and below-ground biomass, and associated flow paths through the sand/mulch filter media. The physical effect of the pools and the vegetation planted on the lateral sides of the channel reduce water velocity and facilitate removal of suspended solid particles and associated nutrients and contaminants. Uptake of dissolved nutrients and adsorption of oils and greases by the plant stems in the pools yields additional benefits. The project also involved removing a stone-lined channel on the downstream end of the project.
