BOULDER FLYCASTERS CHAPTER OF TROUT UNLIMITED

## Boulder Creek at Flatiron Park Habitat Restoration Project Design/Build

Boulder, Colorado

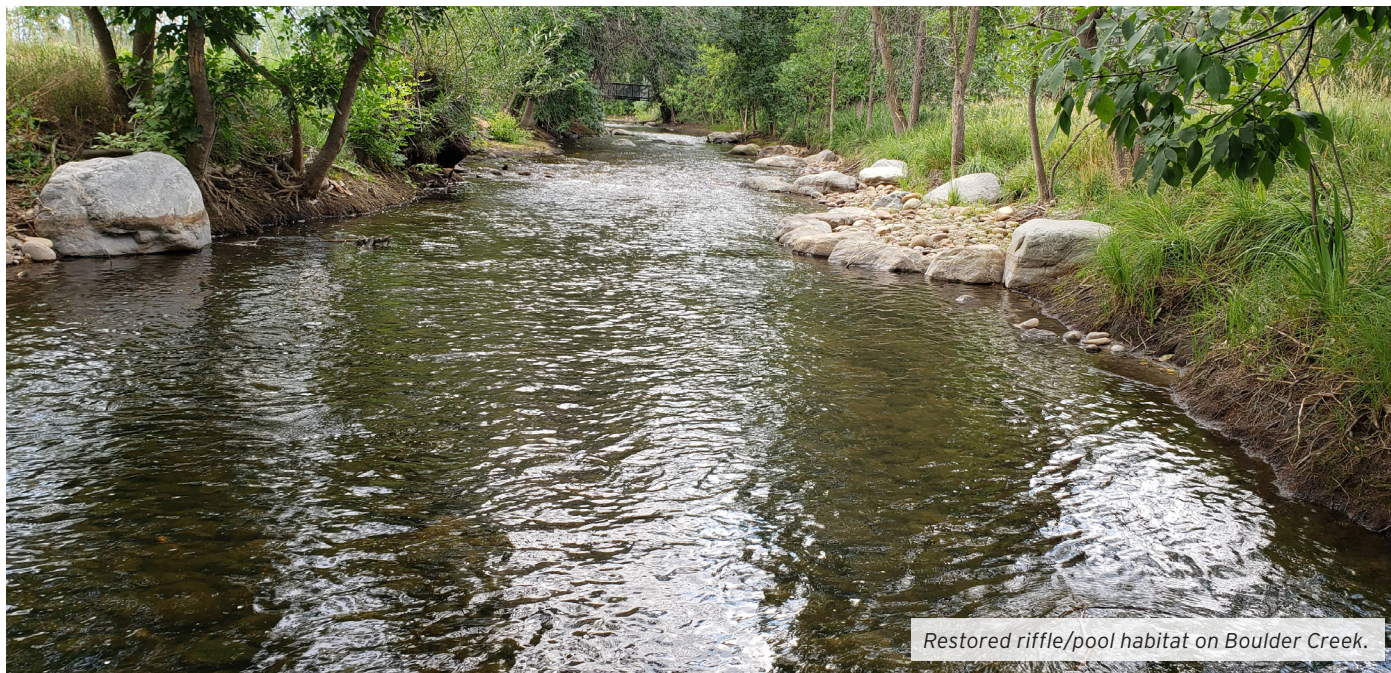
Restored riffle/pool habitat on Boulder Creek.

Working closely with Boulder Flycasters and OSMP to fully understand their goals and vision for the creek, Biohabitats developed a restoration design to increase deep pools for summer and winter refugia, large wood for cover, and structures for concentrating low flows. The design needed to work within the confines of the budget and the constraints of an urban stream channel. All of the large wood and cobble material were harvested on site. Only boulders were brought in. Biohabitats developed customized boulder/cobble structures that narrowed riffles during low flow conditions and flushed pools during high flows. These innovative approaches provided the habitat improvements sought by Boulder Flycasters and the natural feel and minimal disturbance sought by OSMP.
