# Breewood Stream Restoration and LID Retrofit

Wheaton, Maryland

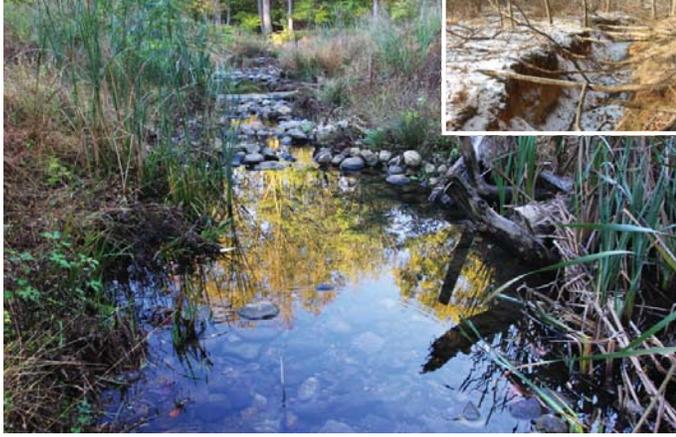
Restored stream with inset of severely eroded initial conditions
