U. S. ARMY CORPS OF ENGINEERS

Fort Detrick Stream Restoration

Fort Detrick, Frederick, Maryland

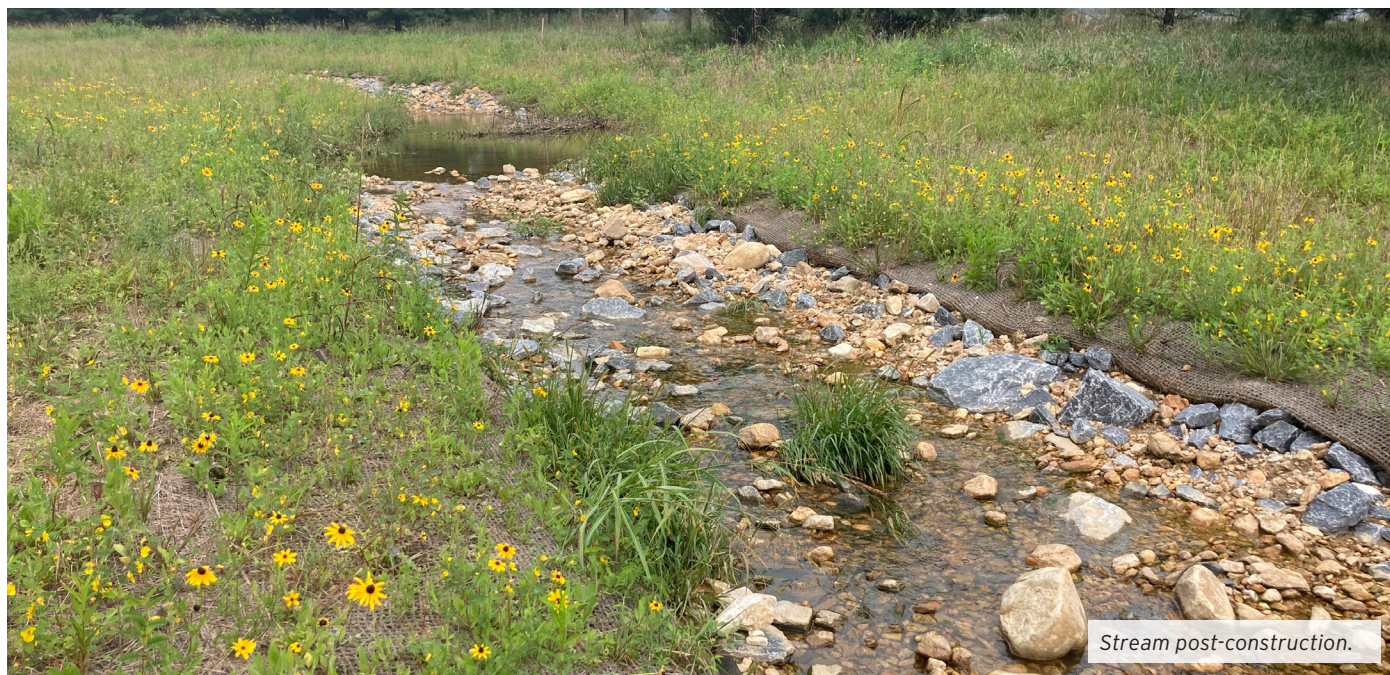
Stream post-construction.

*Floodplain and stream function
is restored to a degraded
tributary located on an active
U.S. Army installation.*
