Marcourt Farms Chagrin River Restoration

Hunting Valley, Ohio

Stream and riparian restoration using an engineered log complex enhances the beauty, accessibility, and ecological function of a beloved State Scenic River and direct tributary to Lake Erie.

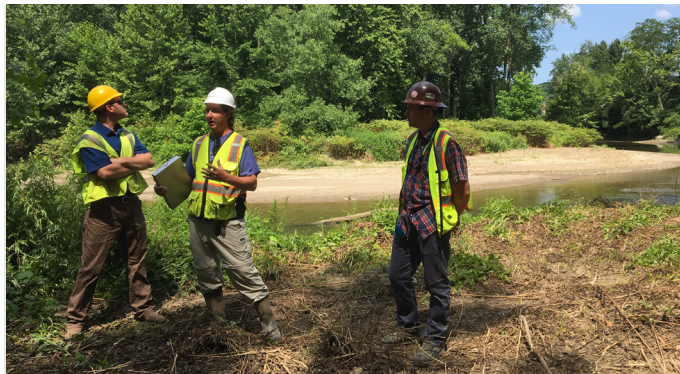
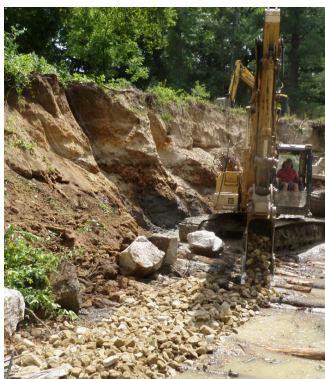
*from top: site visit;
placing the pit run on root wads*
