Mirror Lake Remediation and Restoration

Dover, Delaware

Water quality and habitat are restored to a severely distressed and contaminated urban lake.

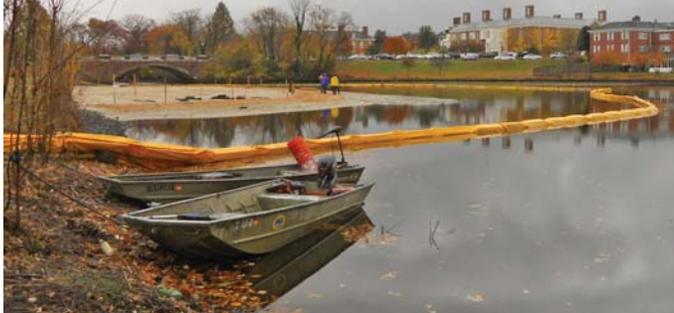
from top: Tidal wetland bench (left background) immediately after planting; Installation of sand utilizing a Telebelt®; Placement of SediMite™ from a boat using compressed air

As part of a multi-phase effort to improve water quality in the watershed, the Delaware Department of Natural Resources and Environmental Control (DNREC) initiated the restoration of Mirror Lake. The project began with remediation. Activated carbon was placed within the lake and surrounding riverine areas in order to bind contaminants in the sediment. Once the carbon was in place, it was the desire of DNREC to also improve the local habitat as well as nutrient cycling within the lake. For help in crafting the design, DNREC turned to Biohabitats.

to improve both the aesthetics of the area as well as the water quality within the lake. Biohabitats also developed a planting plan for the tidal wetland area to restore native vegetation within the lake that will also provide additional habitat for the species that thrive amongst the wetland vegetation.
