## Muckalee Creek Wetland & Stream Mitigation Bank

Sumter County, Georgia

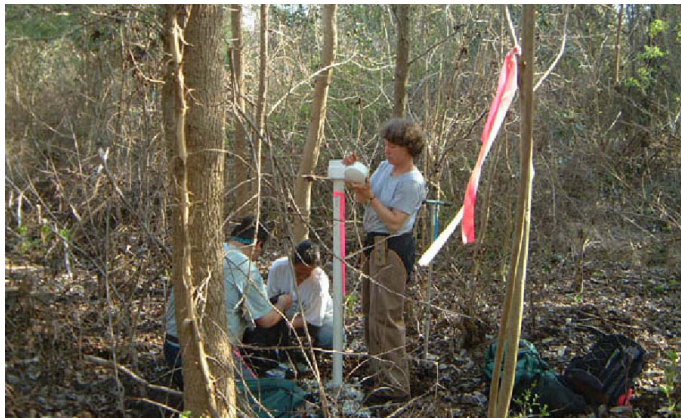
top: Monitoring groundwater levels to help determine restoration approach  
bottom: Restored wetland one month after construction and planting

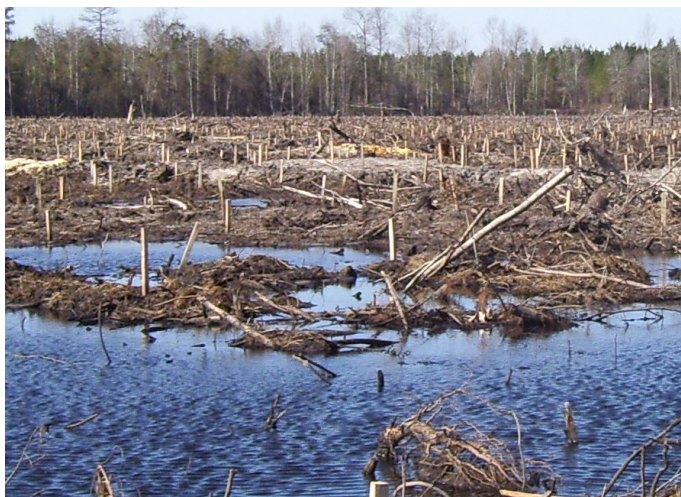
*Over 397 acres of previously drained wetlands restored to a forested wetland supporting a bottomland hardwood swamp.*
