COUNTY OF BERGEN

## Restoration of Wild Duck Pond

Ridgewood, New Jersey

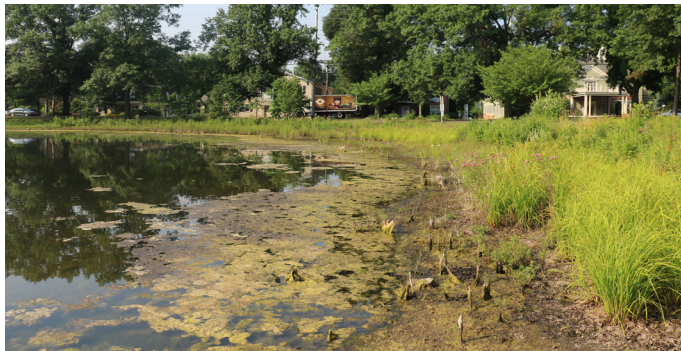
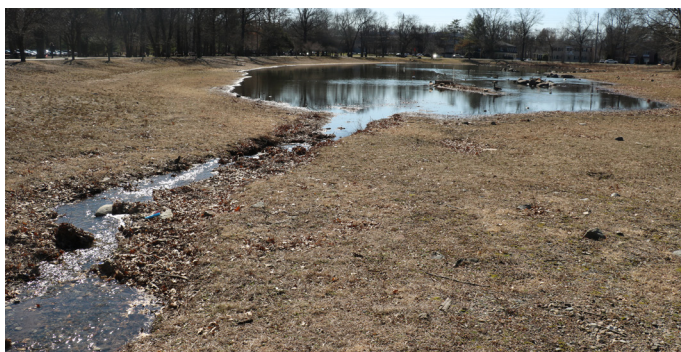
*From top: Algae growth along shoreline; view from the north shows low water level in the pond*

surface flow. Over time, the pond began to experience high nutrient loads, algal blooms, and fluctuating water levels.

Biohabitats began by conducting an ecological and hydrologic assessment of the pond's conditions. This included an examination of a pump system that had run aerators within the pond. Based on the findings, Biohabitats developed several restoration design concepts. Biohabitats then commissioned a topographic and bathymetric survey to
