# River Valley Ranch Stream Restoration

Manchester, Maryland

*Stability, habitat, and ecological function are restored to a rural stream at the heart of a popular summer camp and event destination.*

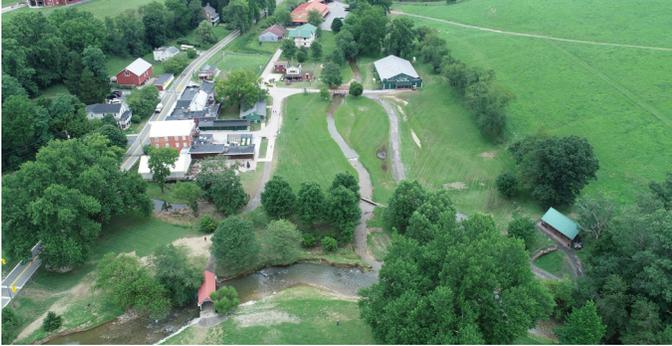
The mainstem of the Gunpowder River (foreground) and Muddy Creek are Central features of River Valley Ranch.

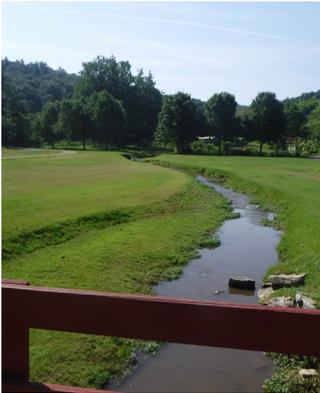
Lack of riparian buffer along the banks of Muddy Creek within the main campus of River Valley Ranch.
