RIVERBANKS ZOO AND GARDEN

Constructed Wetlands Water Treatment for Sea Lion Exhibit

Columbia, South Carolina

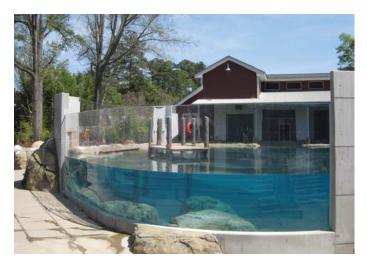
from top: State-of-the-art sea lion exhibit with underwater viewing wall; Newly built constructed wetlands before installation of vegetation

of water. The system includes an underground equalization tank followed by constructed wetlands, which are embedded in the zoo's landscape. After the majority of solids settle out by gravity in the tank, water is pumped through the wetlands, which passively filter nitrogen, phosphorus, and other pollutants before water is returned to the exhibit. The system prevents saline wastewater from being discharged to the municipal sewer, and is projected to save the Zoo approximately 52,000 gallons of water per year. It also greatly reduces the cost of creating the salt water for the exhibit.
