Spring Hill Farm Natural Area Ecological Restoration Design and Construction

Gaston, Oregon

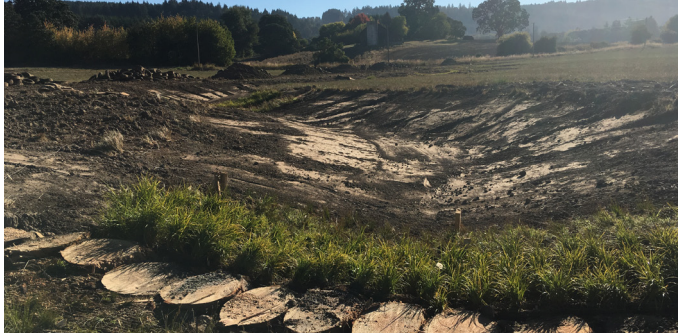
Looking up towards the new channel with grade control structures installed.

Biohabitats then implemented construction of the project. After removing a small dam, the team lined the remaining pond edge with large wood jams to provide fish and wildlife habitat complexity. Biohabitats then removed over 4,000 old truck tires that the previous landowner had used to divert and dewater surface flows for farming. These flows were restored to the surface in new realigned stream channels that included wood debris and vegetated sod mat grade control structures, native riparian hydroseed installation, and native revegetation efforts.

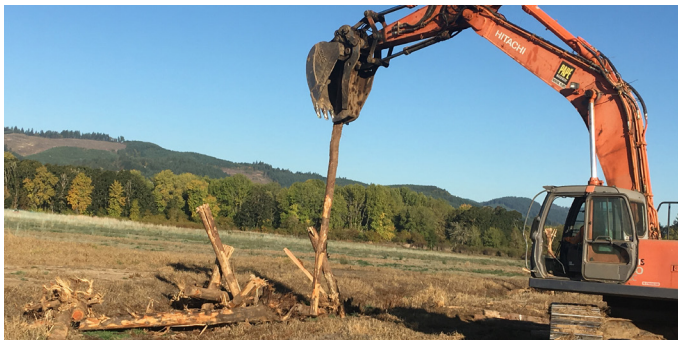
A log jam being installed.
