## Timbers at Troy Stream Restoration

Elkridge, Maryland

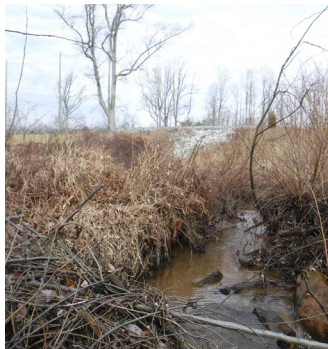
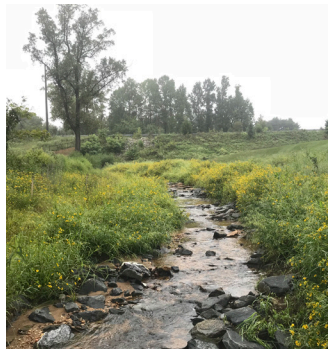
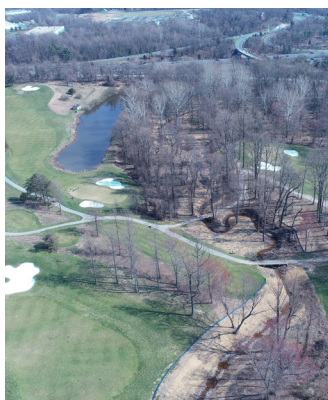
*Clockwise from top left: Before restoration; After restoration; Aerial view of site*

The restoration approach realigned the channel, where necessary, within the existing valley section and imposed a step pool/cascade morphology in the steep upper reach that transitioned into a riffle-pool morphology in the flat lower reach. This approach maximized floodplain reconnection and, by raising the stream invert in the lower reach and

Complementing the channel restoration, a small flood prone bench was created at the edge of the stream and vegetated with native, dense rooting perennial grasses, herbs, and low growing shrubs. Adjacent to the flood prone bench, the work area was restored with a native riparian plant community that was designed to be compatible with the golf course, minimize the need for ongoing maintenance, and provide enhanced water quality benefits, shade, and habitat for the stream channel.
