# Battle Grove UNC Regenerative Stormwater Conveyance

Chapel Hill, North Carolina

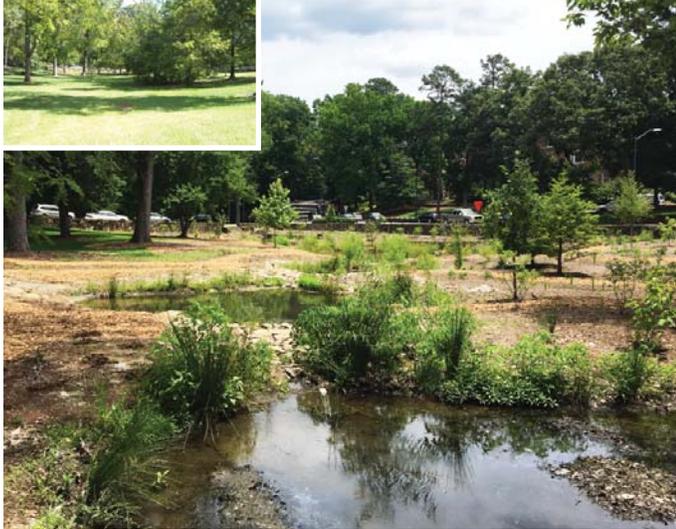
*After restoration with inset of initial conditions*

The design, which daylighted 280 feet of channel and added 118 feet of additional natural channel, featured a network of sand seepage berms, pools, and cobble weirs. These modifications establish the sand seepage hydrology and create a series of vegetated stilling pools, sand seepage beds

replete with above and below-ground biomass, and associated flow paths through the sand/mulch filter media. The physical effect of the pools and the vegetation planted on the lateral sides of the channel reduce water velocity and facilitate removal of suspended solid particles and associated nutrients and contaminants. Uptake of dissolved nutrients and adsorption of oils and greases by the plant stems in the pools yields additional benefits. The project also involved removing a stone-lined channel on the downstream end of the project.
